In-Plant Services, Inc.

- Vibration Analysis
- Balancing
- Laser Alignment
- Thermal Imaging

customer	CF Sauer Co.	equipment	outside compressor area JM
location	Mauldin, SC	component	fuse block
date	August 23, 2002	data storage #	A07

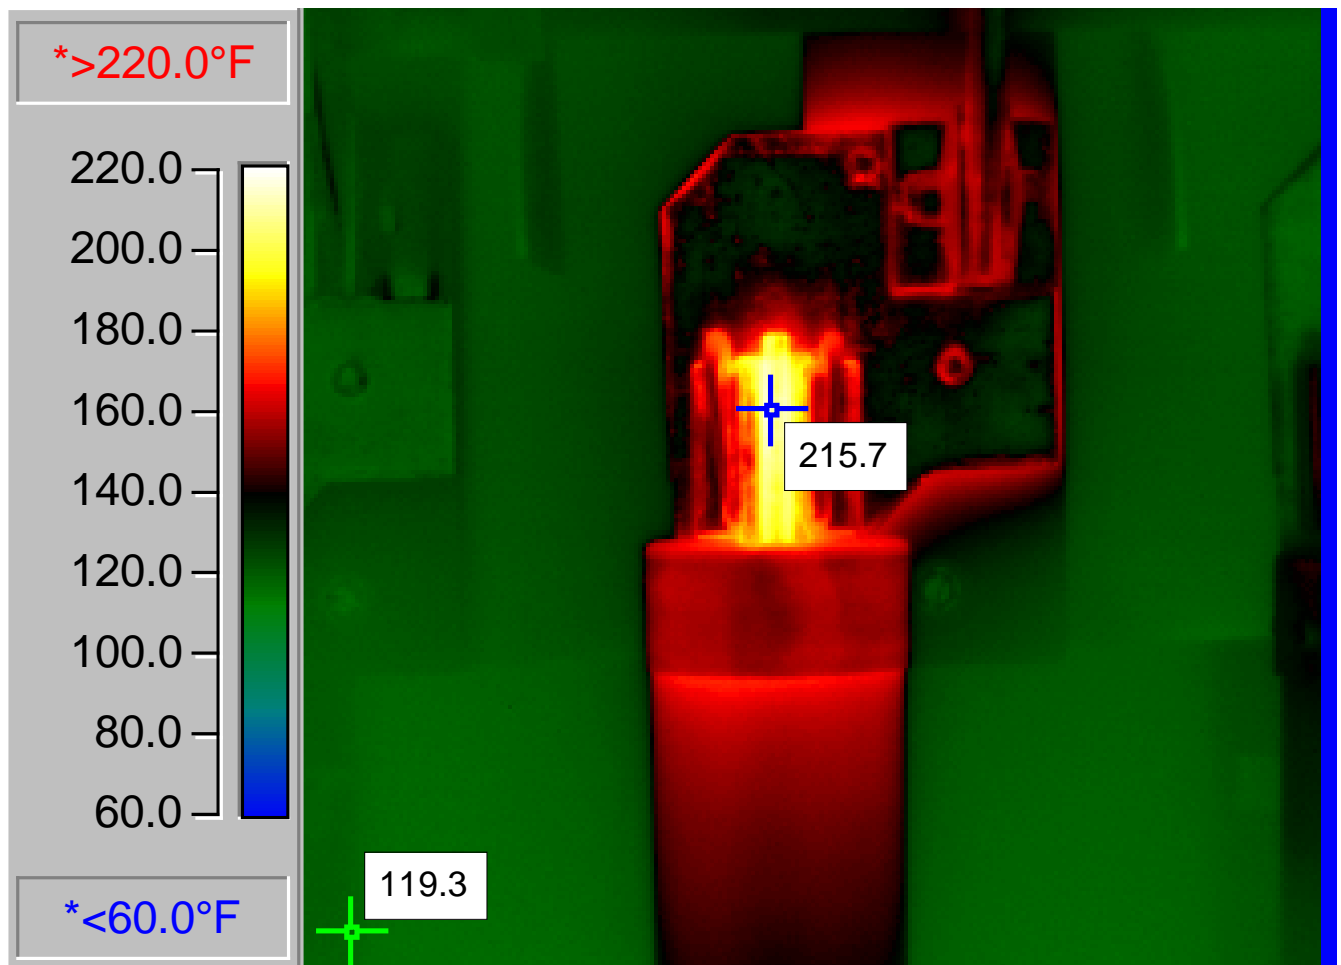
reference	left fuse top			deg F	
reference temp	126.8 deg F		priority 1	> 135	immediate attention required
exception	center fuse top	x	priority 2	65 to 135	corrective measures required
exception temp	215.7 deg F		priority 3	20 to 65	schedule for PM
rise over ref	88.9 deg F		priority 4	1 to 20	document and follow-up
rise over amb	96.4 deg F

pull all fuses, check for dirt or corrosion, loose or annealed clips, replace clip assembly as req.
