# In-Plant Services, Inc.

customer	CF Sauer Co.	equipment	yellow wall, panel KP
location	Mauldin, SC	component	breaker, bottom right
date	August 23, 2002	data storage #	B09

## Thermal Image Data

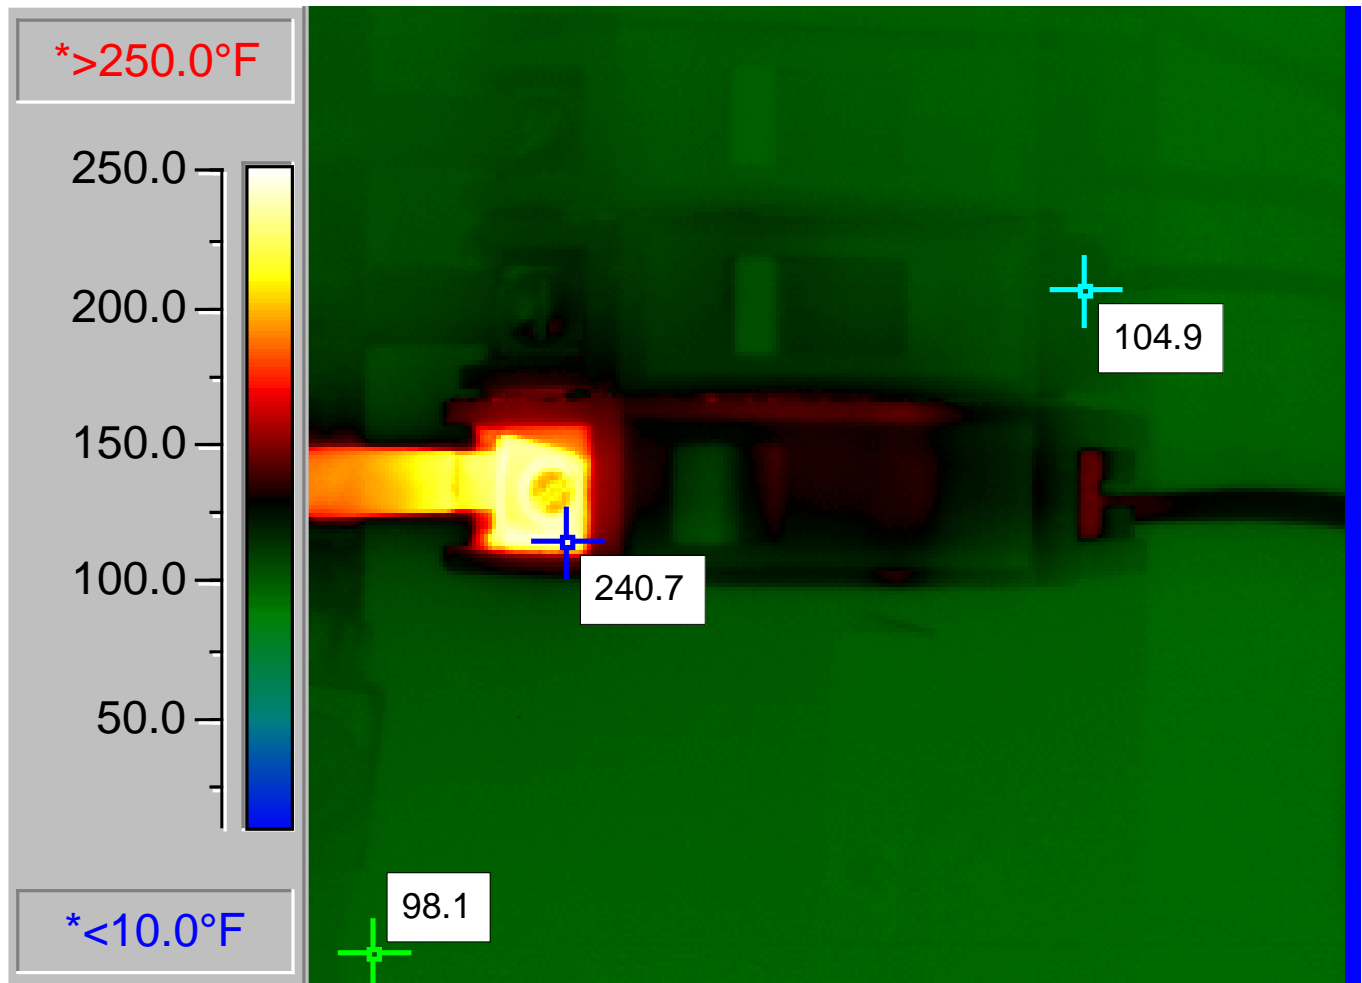
reference	top breaker right			deg F	
reference temp	104.9 deg F	x	priority 1	> 135	immediate attention required
exception	bot breaker left		priority 2	65 to 135	corrective measures required
exception temp	240.7 deg F		priority 3	20 to 65	schedule for PM
rise over ref	135.8 deg F		priority 4	1 to 20	document and follow-up
rise over amb	142.6 deg F

loose screw, corrected.
