In-Plant Services, Inc.

customer	CF Sauer Co.	equipment	mustard house panel HI
location	Mauldin, SC	component	fuse block
date	August 23, 2002	data storage #	A13

Thermal Image Data

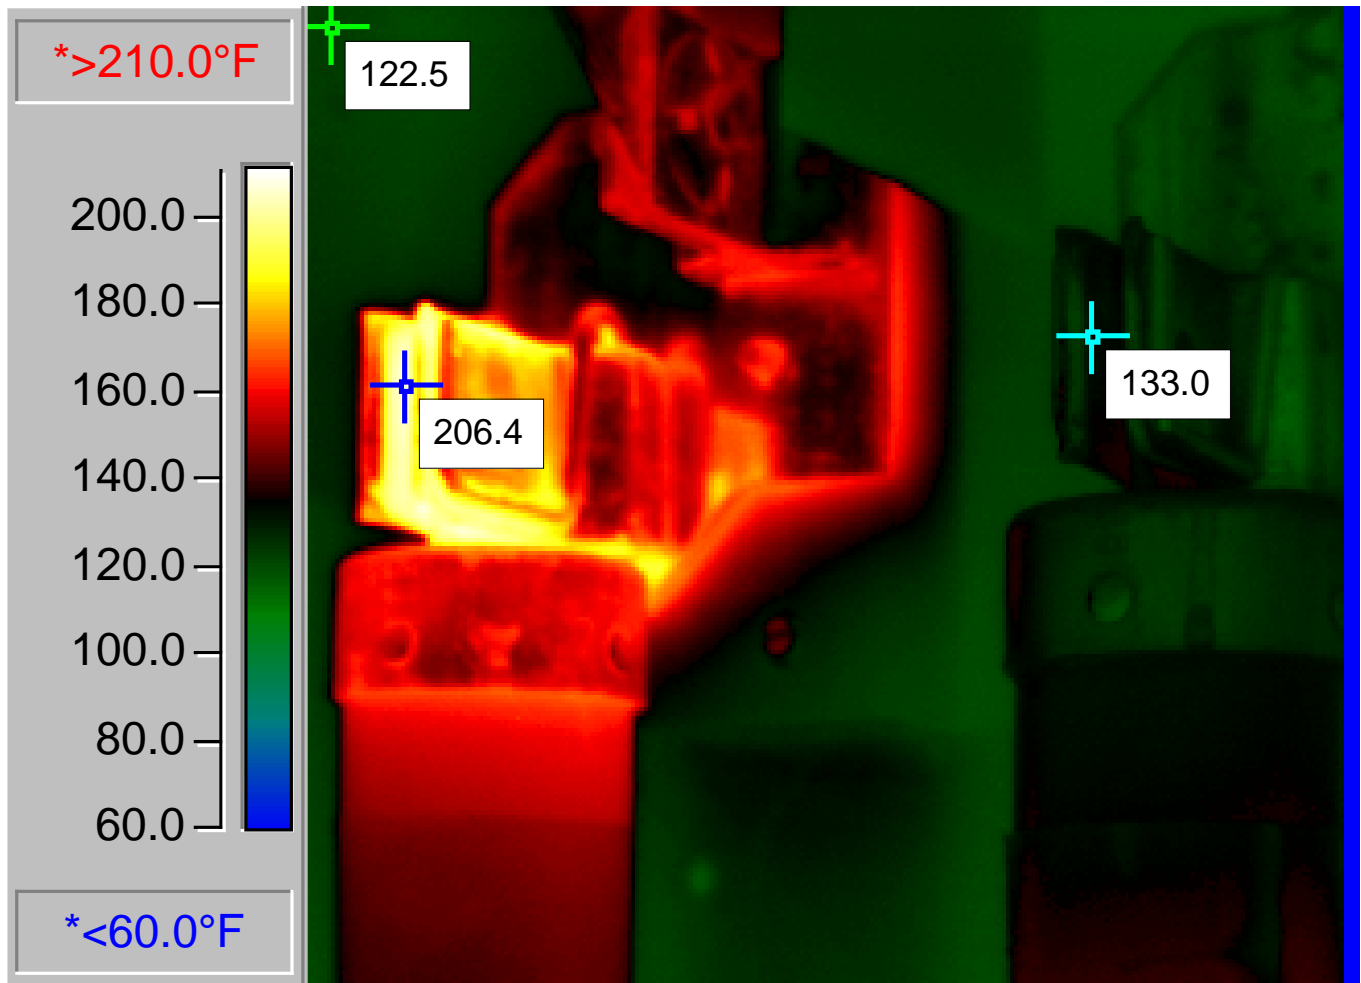
reference	center leg			deg F	
reference temp	133.0 deg F		priority 1	> 135	immediate attention required
exception	left leg	x	priority 2	65 to 135	corrective measures required
exception temp	206.4 deg F		priority 3	20 to 65	schedule for PM
rise over ref	73.4 deg F		priority 4	1 to 20	document and follow-up
rise over amb	83.9 deg F

pull all fuses, check for dirt or corrosion, loose or annealed clips, replace clip assembly as req.
